7. SYSTEM STATE AND ERROR MESSAGES

ERROR 5

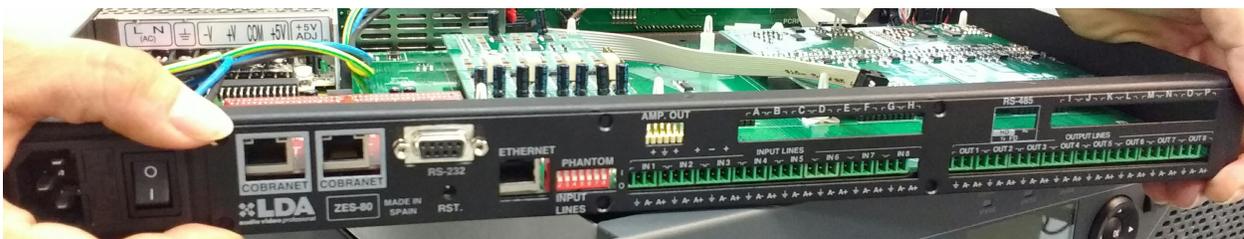
- Open the equipment. To check if the microprocessor board is out of its socket, it is only necessary to remove the back part of the case.
